Vol. 04, Iss. 1 (2026) 48-55, DOI: 10.61552/JME.2026.01.005

Research article

Influence of Rubber Deposits on Tyre - Runway Friction

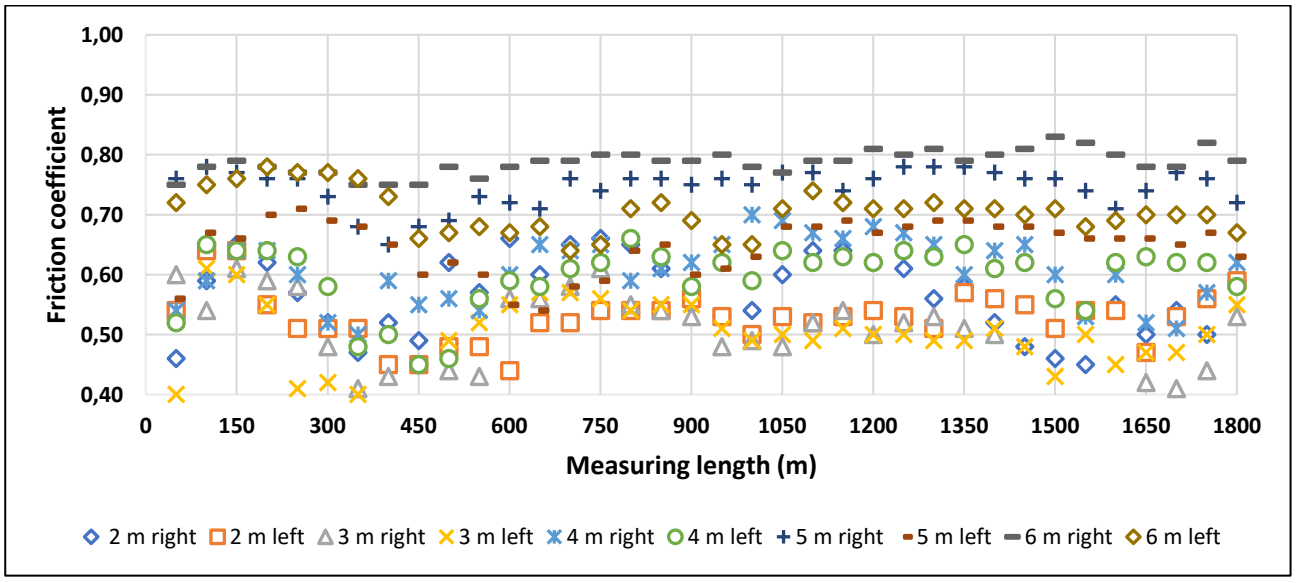
Fig. 2. Measured values of the friction coefficient.

Analyzing the discrete values of the friction coefficient and the shape of graph, it is observed that in the areas between 200 - 600 m and 1000 - 1600 m, the friction coefficient values are lower, this difference being generated by the presence of rubber deposits and the condition of the surface, rubber deposits that are not uniform over the entire surface of the runway.

It is also observed that the friction coefficient values are in the range of 0.40 - 0.83, which is considered to be generated by the local surface roughness characteristics and the presence of rubber deposits as main factors.

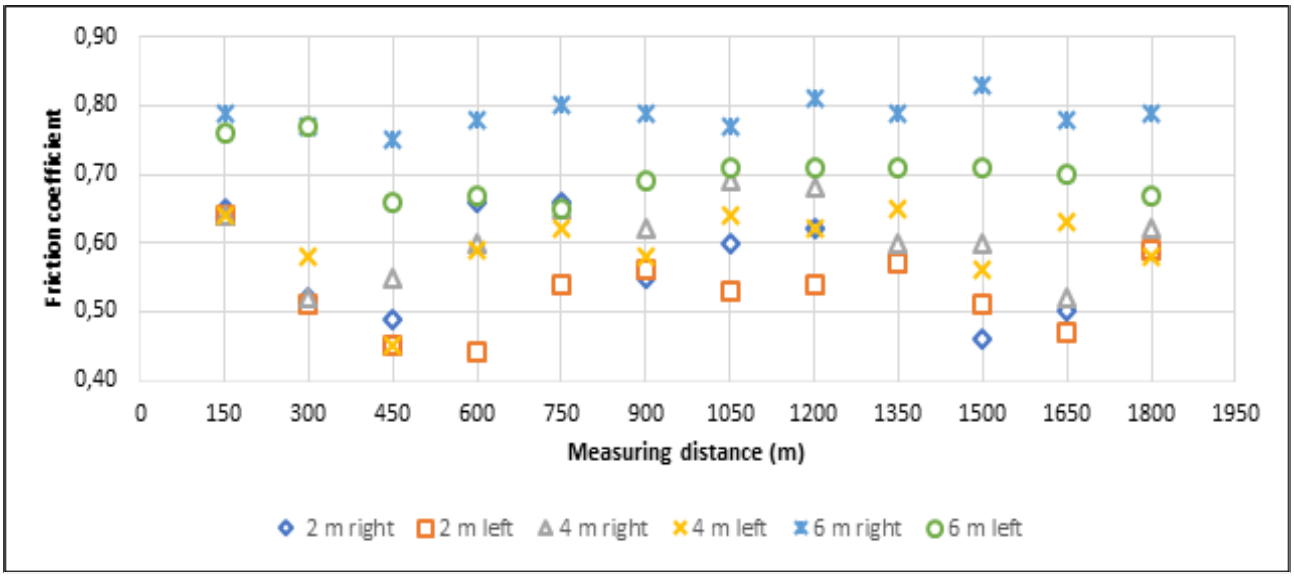
Fig. 3. Measured friction coefficient left/right from runway centerline.

Figure 3 presents the values of the friction coefficients over measurement distances and the lateral distance from the centerline (for 2,4,6 m left and right). From this graph it can be seen that the way in which landings are carried out, either centered or slightly lateral to the axis, and the types of aircraft using the runway (A320 or AT45 aircraft or smaller aircraft) lead to a different rubber contamination of the areas near the runway axis and to different values of the friction coefficients. Thus, the measured values of the friction coefficient are strongly influenced by the situation in that place, where the measuring wheel encounters or not a rubber deposit.

The impact that a large category aircraft has on the surface condition, for example an A320, leads to a contamination over a lateral distance of approximately 4.5 m left - 4.5 m right more pronounced, compared to an AT45 aircraft for which the distance corresponding to the main landing gear is approximately 2 m left and 2 meters right.

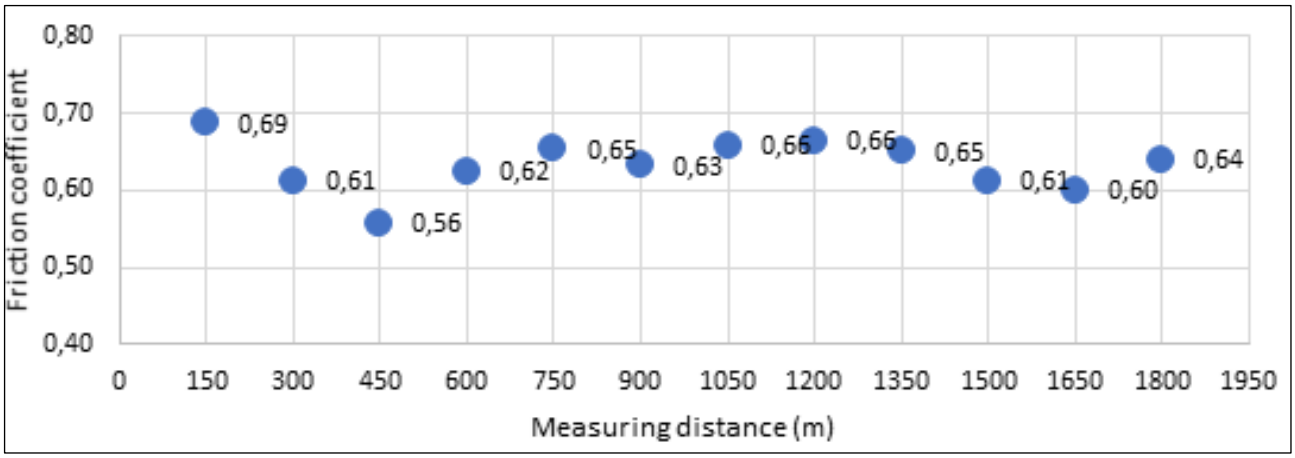
Fig. 4. Average values of friction coefficient.

In the case of measurements, the variation of the average values, calculated as an arithmetic mean, of the friction coefficient, is from 0.56 to 0.69. This highlight the areas that are predominantly contaminated with rubber deposits and are subject to majority of landings, respectively 200 - 600 m and 1200 - 1600 m. As can be seen until now in the study, the contact surface tyre-runway, contaminated with rubber deposits, significantly influences the friction coefficient values. The analysis continues with a comparation of two measurement lines, the 2 meter line and the 6 meter line right from runway centerline. The 2 meter line corresponds to the area where rubber deposits are predominant due to frequent landings on those areas and the 6 meter line corresponds to the area where landings are very rare (these correspond to areas where class D aircraft could put their wheels down if they landed).

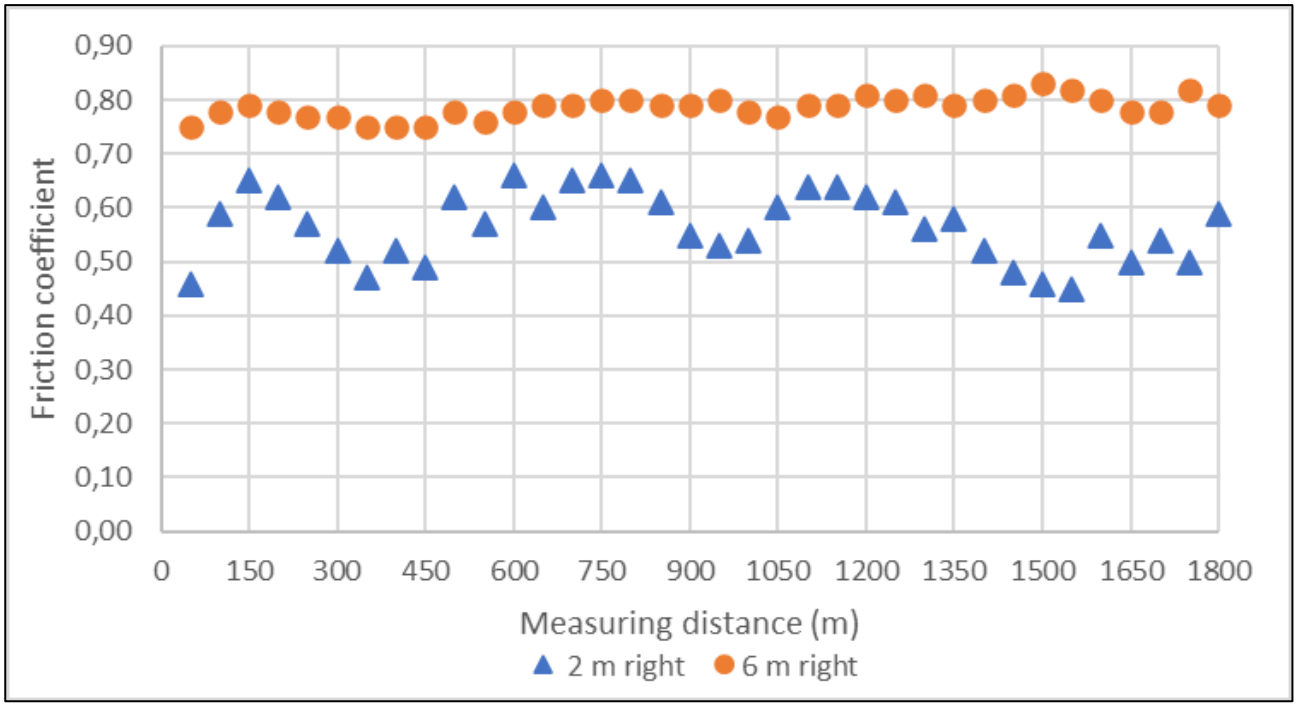
Fig. 5. Friction coefficient values 2 meter and the 6 meter right from runway centerline.

For the 2 m line the values of the coefficient of friction vary between 0.45 and 0.66. On the other hand for the 6 m line the values of the coefficient of friction have a minimum of 0.75 and a maximum of 0.83.

Thus a decrease of approximately 0.2 in the value of the friction coefficient, from a clean and dry surface to a surface contaminated with rubber deposits, is significant. It can be seen from what is presented, that rubber deposits on the runway significantly influence the values of the friction coefficient, determining in the studied case a decrease of approximately 0.2 in its value.

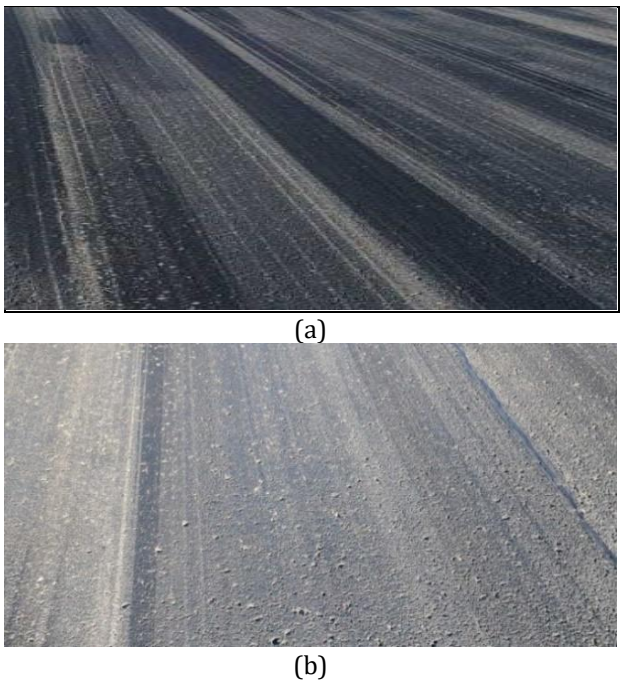
Fig. 6. Visual comparison regarding rubber contamination (a) area 1, (b) area 2.

During field observation of the runway, the clear visual differentiation of area 1 (0-4 meters from runway centerline) and area 2 (4-6 meters from runway centerline) and their degree of contamination due to the rubber deposits on the runway surface was observed. Fig. 6 and Fig. 7 show the difference in color and texture of the contaminated surfaces.

As can be seen, there are clear differences between the contamination of the two areas, the friction is thus different, the presence of rubber deposits negatively influencing the friction characteristics. The change in color of the runway surface from gray to black is an indicator of the degradation of the friction conditions and the contamination on the surface.

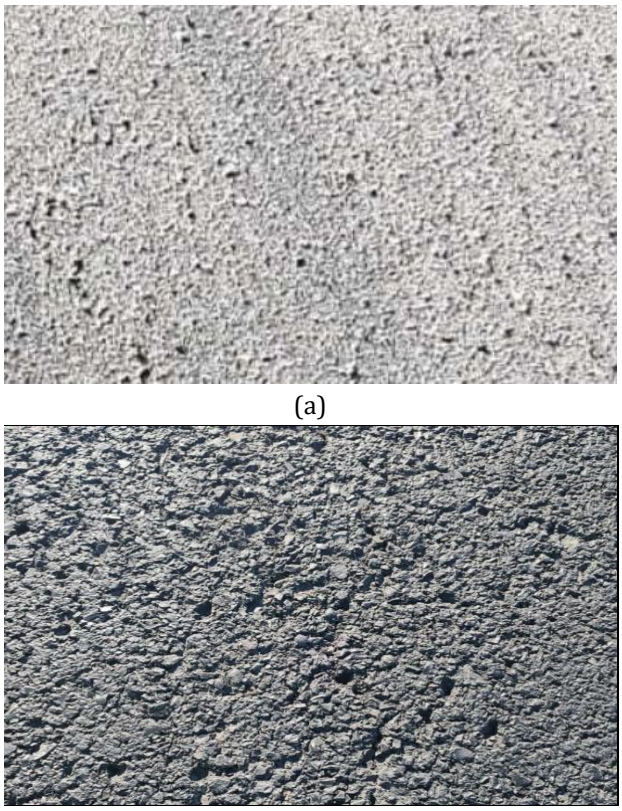
Fig. 7. A closer view of rubber deposits (a) area 1, (b) area 2.

The data obtained during the measurements on the surface, without contamination with rubber deposits, are located in the range of 0.45-0.66, while the values on the clean surface were in the range of 0.75 -0.83. On field visual observations and tactile assessment confirms that areas with lower friction coefficient are corresponding to those darker in color (black in our case).

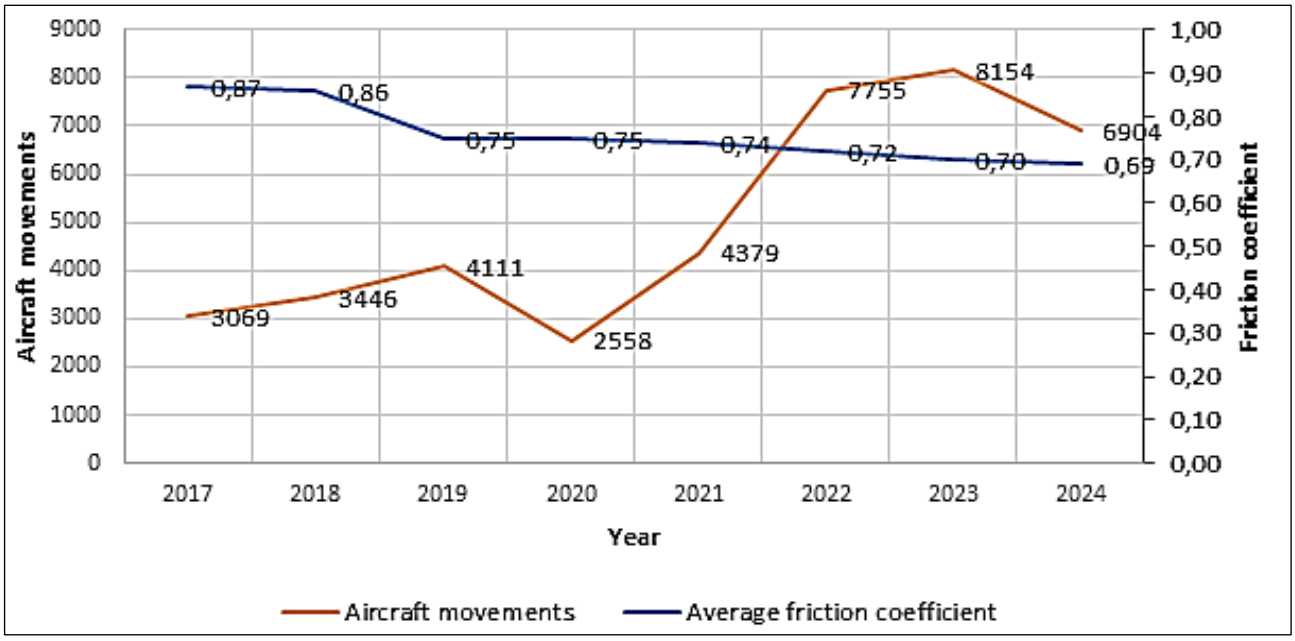
Fig. 8. Friction decay related to airport traffic.

If we analyze the following available data (from airport authority): in 2017 the average coefficient, calculated as an arithmetic mean of the coefficients for each third of the runway surface, was 0.87, compared to 2024 where the average coefficient is 0.68, the number of aircraft movements with significant impact on the rubber contamination of the runway: almost 33500 movements (aircraft type A320/21 and other types of aircraft that used the running surface), a decay of approximately 0.2 in the friction coefficient is observed.

The graph, figure 8, shows the significant decrease in the friction coefficient with the increase in traffic (the difference between movements in 2018 almost 3500 movements and 2019 just over 4000 movements, a significant increase in traffic that led to an increased use of runway surface, that led to the decrease of the friction coefficient). It is observed also a slight decrease in the friction coefficient during the COVID period (2020-2021) when aircraft movements were significantly reduced, which makes sense reported to the recorded traffic.
